# TRANSIENT PHRENIC NERVE STIMULATION IN A PATIENT WITH SINGLE CHAMBER PACEMAKER: CASE REPORT

*The article presents a clinical observation of a patient with episodes of phrenic nerve stimulation after inadvertent permanent ventricular pacing from the middle cardiac vein. The methods of early diagnosis of this complication and techniques for its prevention are described.*

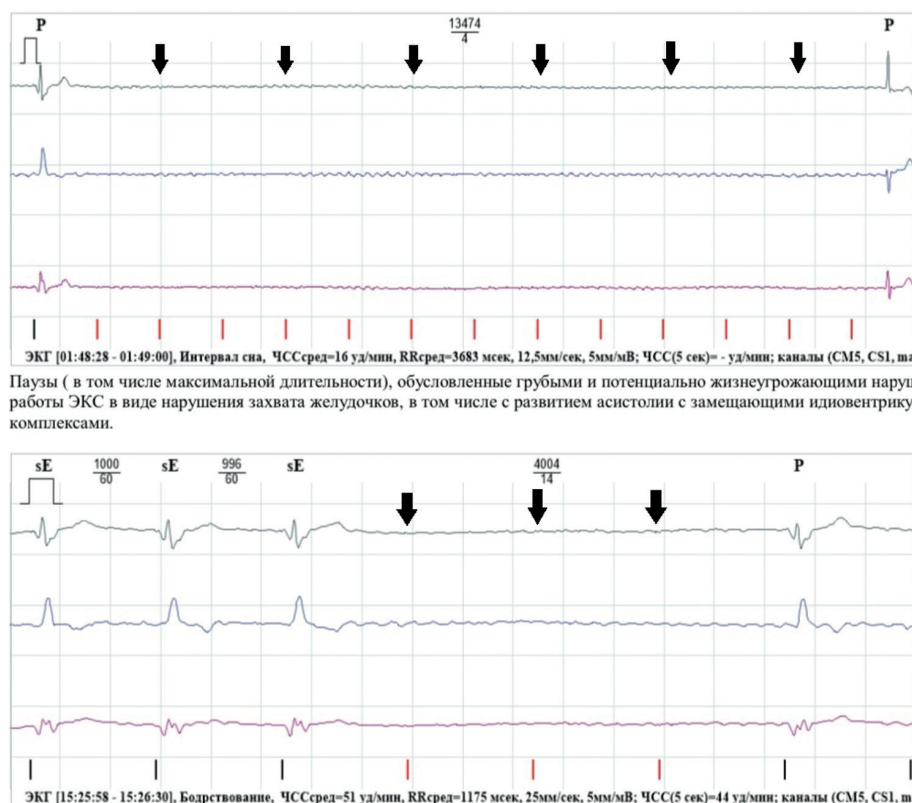
**Fig. 1. Fragment of Holter monitoring with ineffective ventricular stimulation. Arrows indicate ineffective ventricular stimuli.**

In January 2016, the patient underwent pacemaker replacement due to critical battery exhaustion, and SEN-SIA SR pacemaker (Medtronic, USA) was implanted. Postoperative pacemaker programming showed no abnormalities in the function of the implanted electrode, documented stimulation threshold was  $<1$  V. Due to the occurrence of episodes of vertigo in October 2023, the patient underwent Holter monitoring on an outpatient basis, which revealed episodes of ineffective ventricular stimulation with pauses up to 13.5 s (Fig. 1), in connection with which the patient was urgently hospitalized in our hospital.

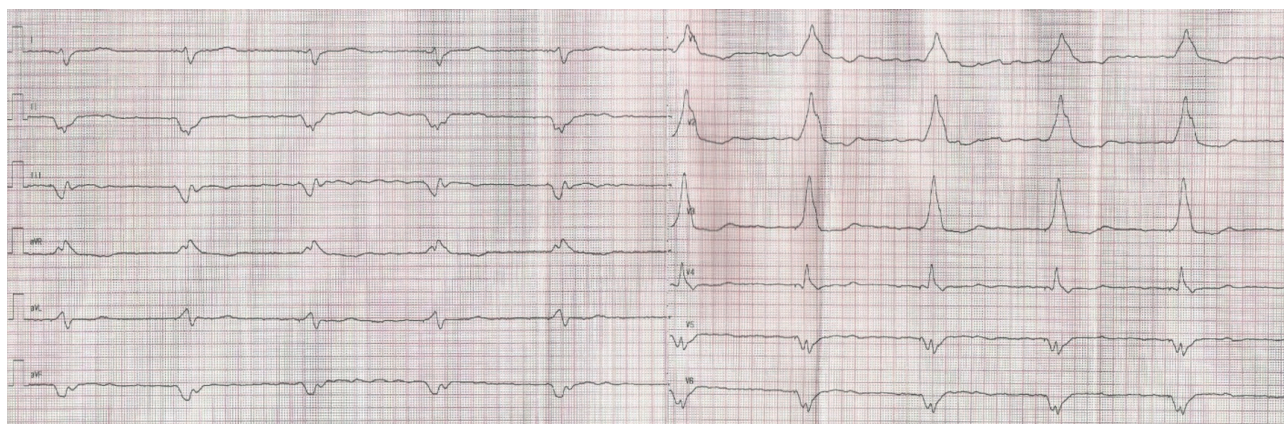
When analyzing the ECG on admission, QRS morphology of the type of complete blockade of the right bundle branch of the Hiss with a QRS width of 200 ms was noteworthy (Fig. 2), which made it possible to suspect left ventricular stimulation. ICU pacemaker programming re-

vealed an increase in stimulation threshold to 2.5 V, while the pulse amplitude in the pacemaker settings was also 2.5 V. Thus, episodes of ineffective ventricular stimulation were associated with a lack of a safe amplitude margin (a twofold margin is recommended for chronic threshold stimulation). The automatic stimulation threshold detection function has been programmed into monitor mode; when attempting to set automatic stimulation threshold tracking, after capture testing, enabling this function is not recommended by the device.

**Fig. 2. Electrocardiogram of the patient on admission. Effective ventricular stimulation. QRS morphology is of the type of complete right bundle branch block.**

Increasing the pulse amplitude to a safe level of 5.0 V (2x), resulted in the appearance of diaphragm stimulation in the left subcostal region, which the patient had already experienced with some frequency since 2007. The prognostic life of the pacemaker battery after the newly programmed parameters was  $<2$  months, so the decision was made to replace the pacemaker and ventricular electrode.

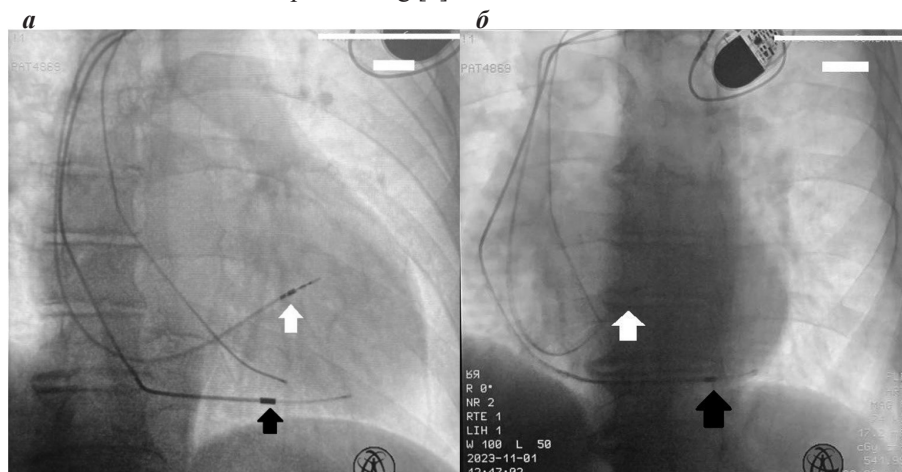
The operation was performed for emergency indications, given the patient's dependence on pacemaker and discomfort from constant stimulation of the diaphragm. Fluoroscopy in posterior-anterior (PA) and left lateral (LAO) projections revealed positioning of the ventricular electrode in the CS-MCV branch (Fig. 3). The electrode was mobilized, but retrieval by simple traction on the stylet was not possible. In the absence of systems for electrode extraction and the risk of CS damage, it was decided to refrain from further attempts to extract the electrode. A new electrode was implanted into the interventricular septum with satisfactory stimulation parameters (ventricular electrogram amplitude 16.1 mV, stimulation threshold 0.6 V). A new Reply SR pacemaker (Microport CRM-Sorin, China) has been connected.

**Fig. 3.** Intraoperative fluoroscopy in posterior-anterior, PA (a) and left oblique projection, LAO (b). Black arrows indicate the electrode in the MCV. White arrows indicate the newly implanted electrode in the interventricular septum.

In our clinical case, the cause of diaphragm stimulation was apparently stimulation of the diaphragmatic nerve by the electrode located in the MCV, although direct stimulation of the left dome of the diaphragm cannot be excluded. If we refer to the design of the implanted electrode with passive fixation (Polyrox PX-60-BP, Biotronik, Germany), it can be noted that the distance between the distal end of the electrode and its ring is

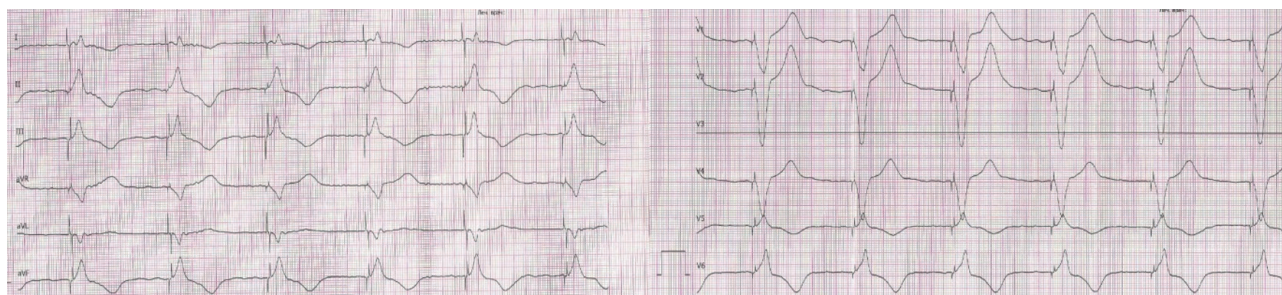
The postoperative period proceeded without peculiarities. The sensation of pulsation in the left subcostal region has completely disappeared. On ECG performed at 1 day after surgery- effective ventricular stimulation with QRS morphology of the type of complete blockade of the left bundle branch of Hiss (Fig. 4). The patient was discharged on the 4th day after surgery in satisfactory condition.

**Fig. 4.** Electrocardiogram of the patient at 1 day after surgery. Effective ventricular simulation. QRS morphology in lead V1 is of the type of left bundle branch block.

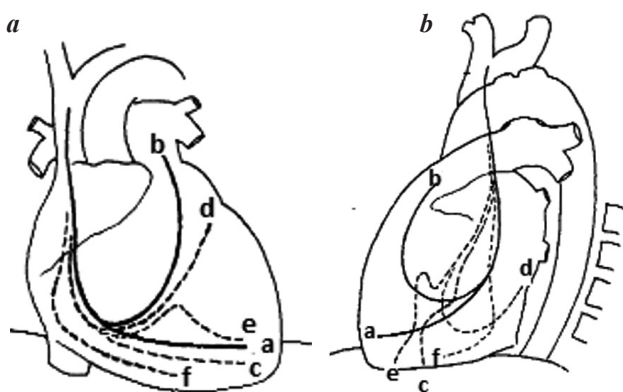
both ventricles. In most cases, the mouth of the MCV is located near the mouth of the CS. During the implantation procedure, if certain rules described below are not followed, the ventricular electrode may inadvertently end up in the MCV, which may not be recognized in time because the anatomical course of the MCV resembles the position of the electrode in the apex of the right ventricle during fluoroscopy in the posterior-anterior (PA) projection (Fig. 5) [4, 5].

**Fig. 5. Schematic location of electrodes in posterior-anterior (a) and lateral (b) fluoroscopic projections. The solid line indicates electrodes: a - in the apex of the right ventricle, b - in the pulmonary artery. Dotted lines indicate electrodes: c - in the middle vein of the heart, d - in the large vein of the heart, e - in the posterior vein of the heart, f - in the small vein of the heart [5].**
